NEWS

01/03/2006

## Report on the occurrence of a Be-treated blue sapphire of commercial importance

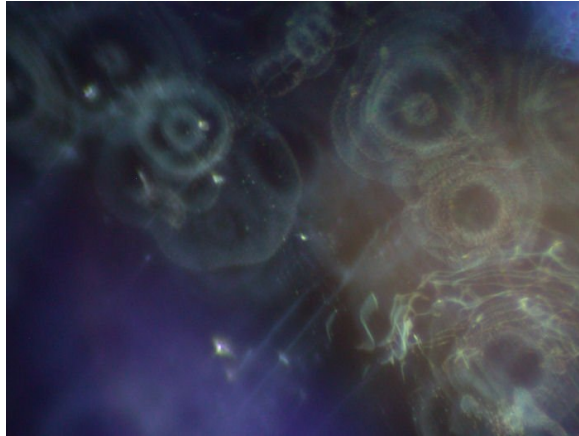
Circular inclusions resembling "fish eggs" found in a Beryllium-treated blue sapphire.

**Note:** The sapphires which have circular inclusions of the very special kind are a good indication of Beryllium-treatment as far as the work of our lab is concerned. They are very subtle differences between circular inclusions previously seen in heated stones and the once recently appearing. So, naturally this will give some room for misunderstanding. Studying them in the microscope versus just looking on a picture might be difficult as well, because the three-dimensional character of the prominent circular inclusions is difficult to capture in a picture. It must be noted that inclusion may be completely absent and that sapphires from different origins may also have different inclusion properties. For example, blue and milky halos around rutile and zircon appeared in Beryllium-treated sapphires from Madagascar. Again, it may be possible to find them in other heated materials, but for the moment, the ones that appear here in the laboratory are Beryllium-treated.

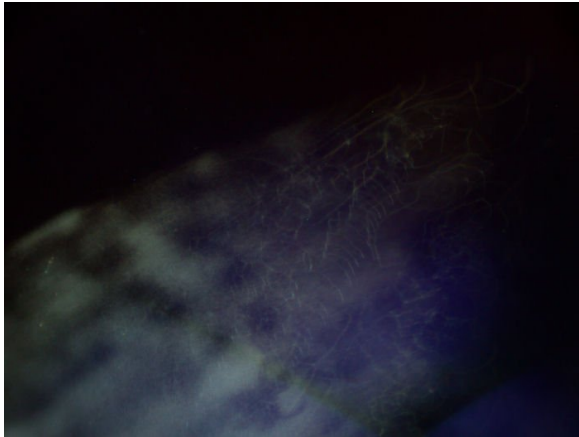
Whitish lines in the shape of skeletons
